W1 Circumferential Cracking of Reactor Vessel Head Penetration Nozzles

RIC 2002

Dominion Response to Bulletin

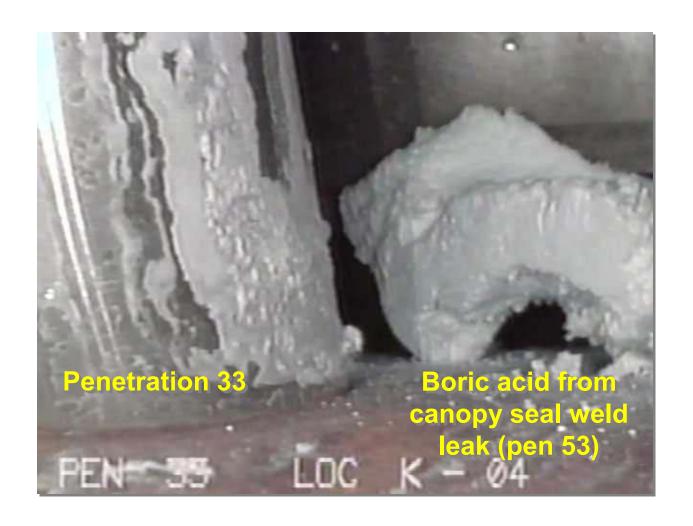
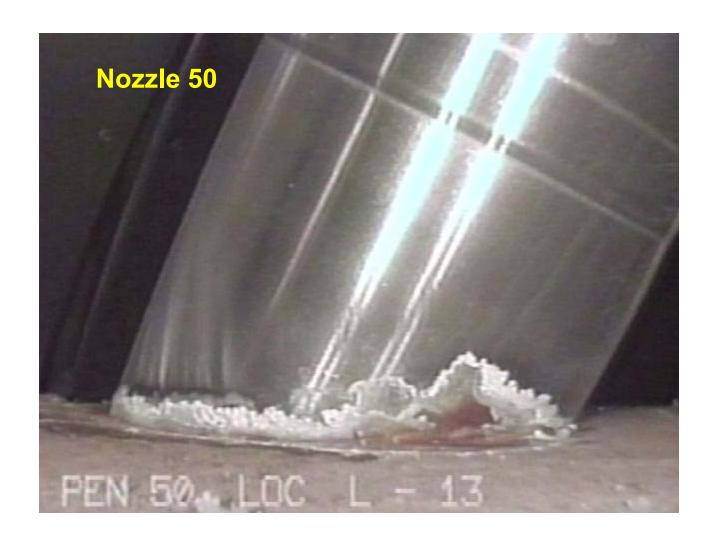
• Penetration 50

- Penetration not in boric acid field from canopy seal weld leak
- EC of tube showed non-recordable indications in tube (98% coverage)
- EC showed 4.3 mm indication in the clad (not recordable)
- UT of tube ID no recordable indications but limited to 97 degrees
- LP of weld indications in clad and crater crack in the weld (crater crack was ground out)
- Removed thermal sleeve to obtain full access full access UT revealed no recordable indications including a circumferential UT scan

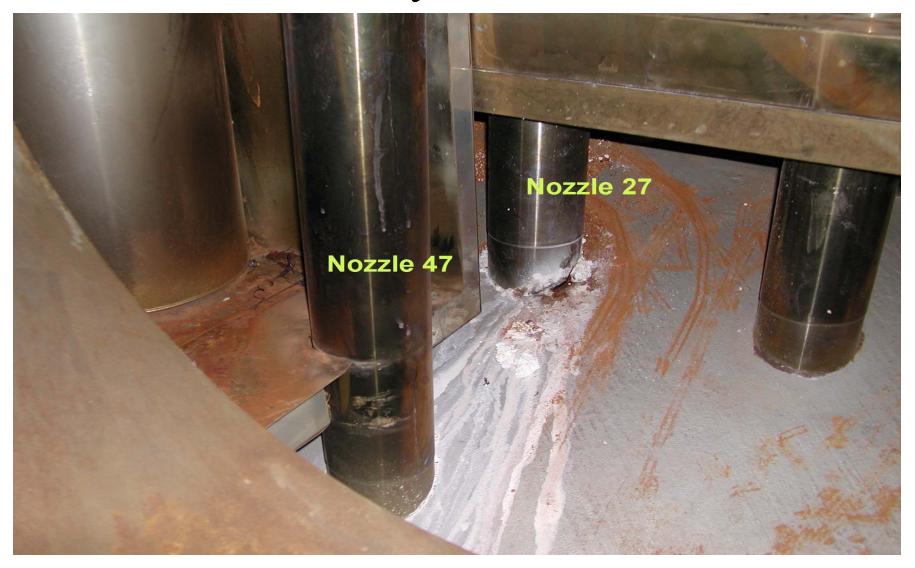
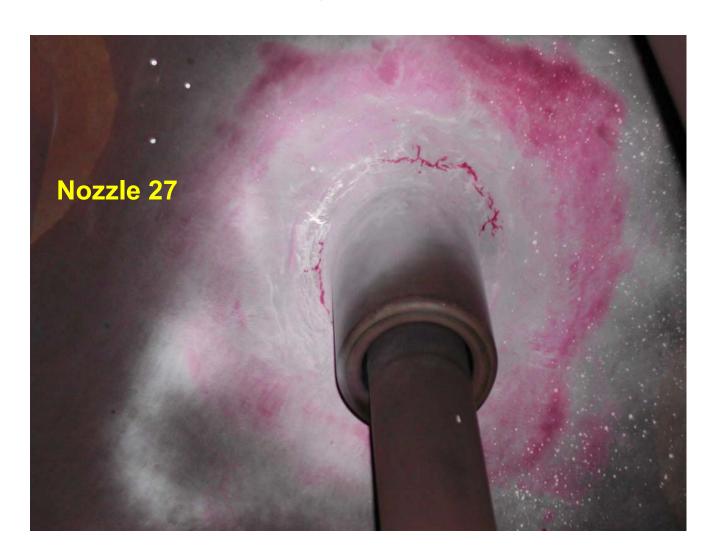
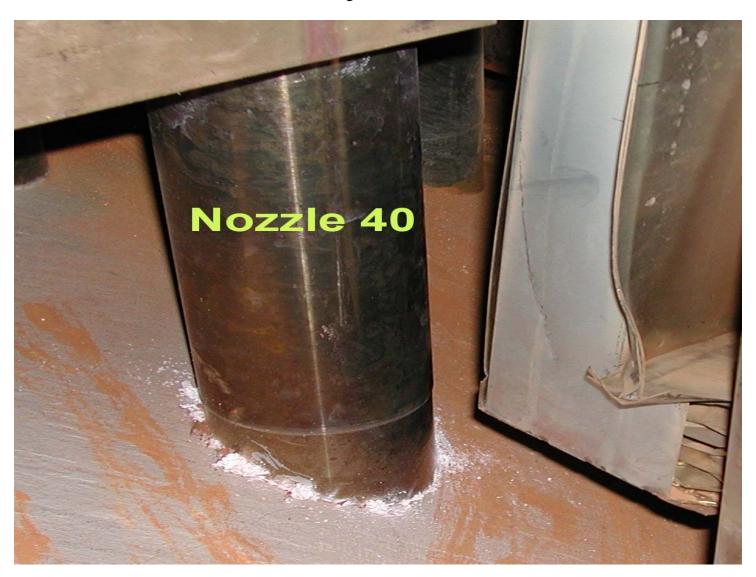
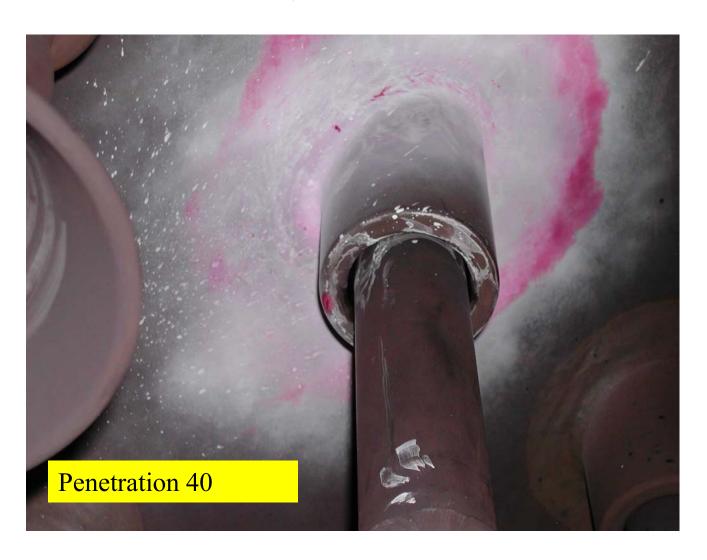
- Axial UT probe used on 16 penetrations (including 6 cleared by air). No reportable indications
- Circumferential UT probe used on 5 penetrations with LP indications in J-groove weld. No reportable indications
- Vendor had no remote J-groove weld inspection capability
- Manual liquid penetrant (LP) on 10 penetrations
- 2 penetrations had circumferential LP indications in center of the weld, highly branched in appearance (penetration 27 had wet boron deposits on top)
- 4 penetrations had rejectable indications that could not be ground out
- 4 penetrations had indications that were ground out and accepted

- 6 penetrations were reported to the NRC as a non-emergency 8-hour report in accordance with 10 CFR 50.72(b)(3)(ii)(A) and 50.73(a)(2)(ii)(A), a condition that results in a principal safety barrier being seriously degraded
- All indications confined to weld, hasn't propagated to tube
- All 6 penetrations repaired
- Dose expended: 161 man-rem
- Templating performed for future head replacement

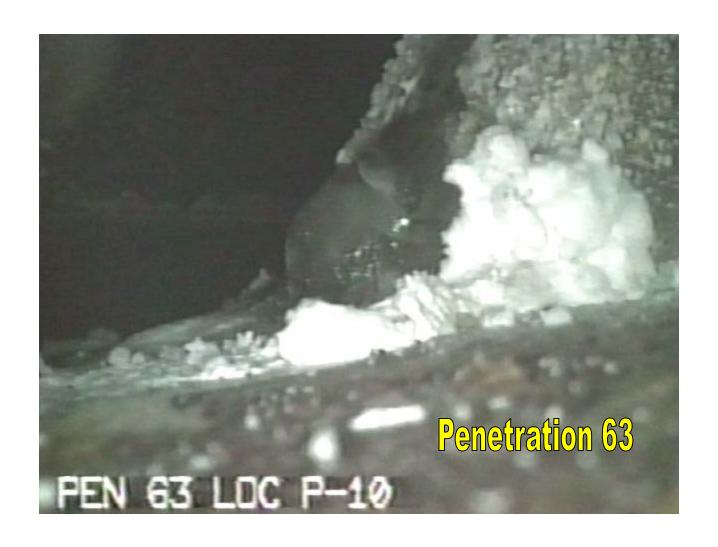
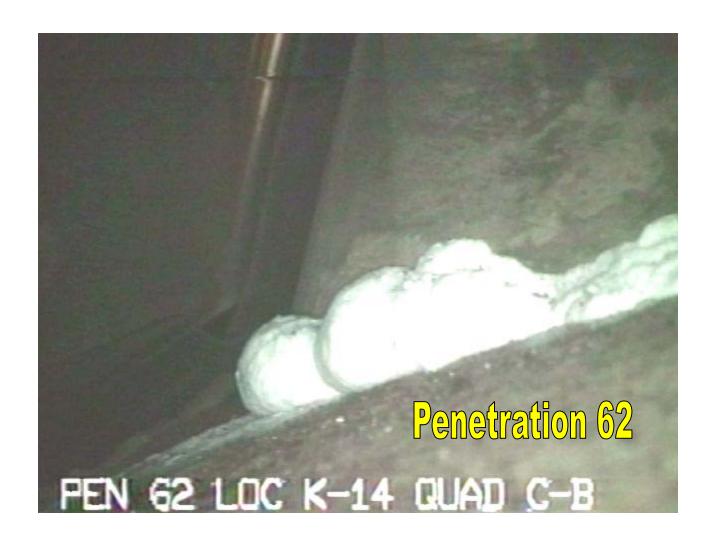
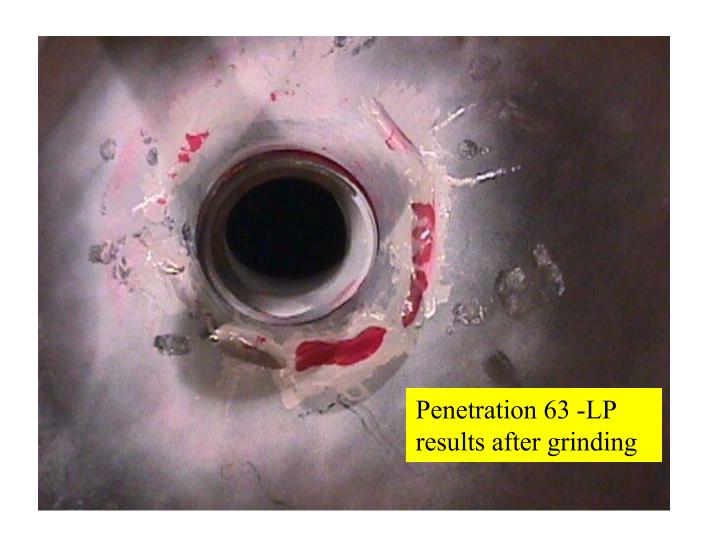
- Thermal sleeves removed on penetration 62, 63 to facilitate inspection (penetration 51 is T/C)
- Performed EC in tube indications on all tube IDs
- Performed axial and circumferential UT axial indications shallow and accepted by flaw evaluation
- Bypassed EC in J-groove weld and went straight to LP examination. Indications in clad believed to be from original fabrication similar to Unit 1
- Manual grinding and then remote grinding on penetration could not clear indication
- Temperbead and embedded flaw relief requests approved as repair methodology for all 3 penetrations

- NDE campaign (continued)
 - Boat sample removed from one penetration
 - Failure analysis revealed solidification or "hot" cracking confined to the Alloy 182, or butter, material.
 - A few of the hot cracks were connected to the wetted surface.
 - Some PWSCC noted which may have connected the hot cracking to the surface or may have occurred after the hot cracking connected to the surface
 - Ringhals Unit 2 found fabrication flaws between J-groove weld preparation and vessel in 1992. Identified after grind out of penetration 63
 - Dose expended: 69.947 man-rem
